The Carancas Meteorite Fall, 15 September 2007
Official INGEMMET initial report
Released 21 September 2007

Luisa Macedo F. & José Macharé O.

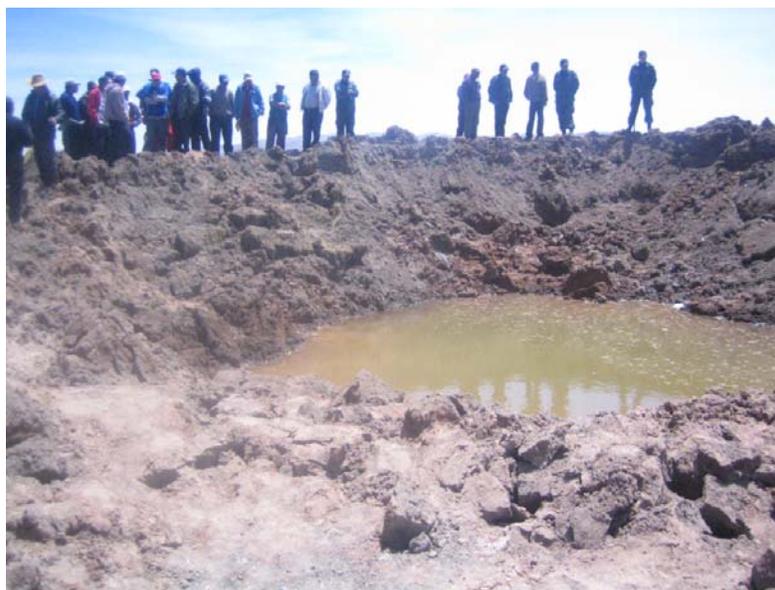
Figure 2.- Carancas crater lake and ejecta rim. Looking to the north.
